# Kinderhook Creek Resiliency Study

Villages of Valatie & Kinderhook, New York

## Study

July 2021

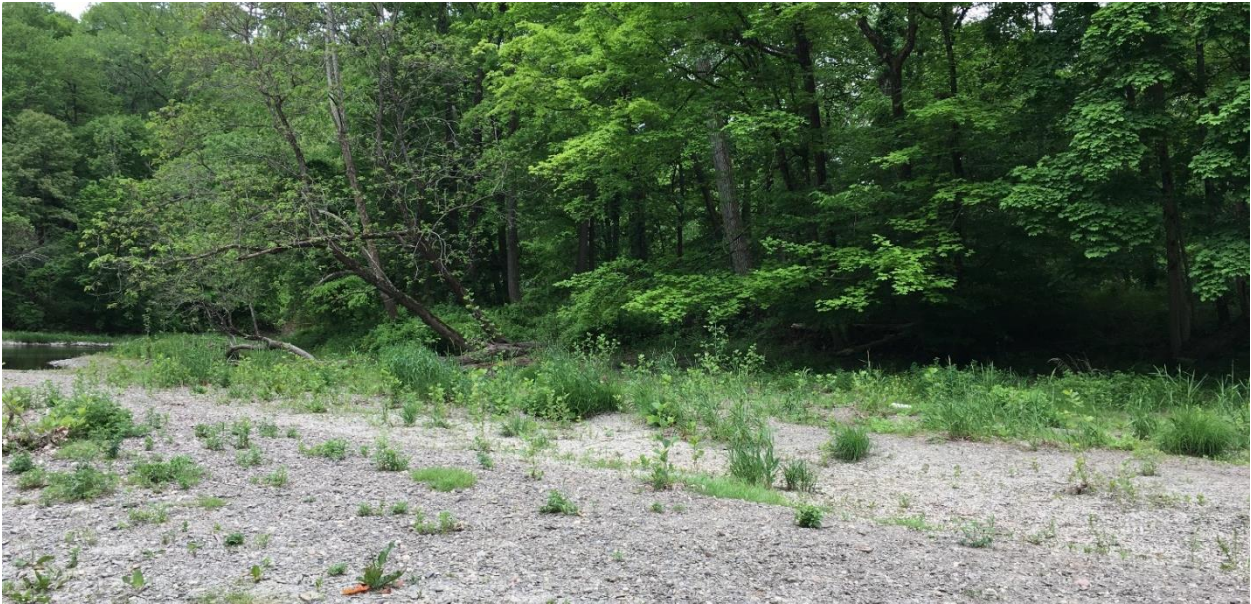
In a few locations, gravel shelves are found adjacent to the shore. These stretches are likely under water when spring rains and snow melt raises the water levels of the creek. Sparse herbaceous vegetation is present and reflective of the species composition found inland.

Figure 3: Gravel expanse adjacent to the shore.

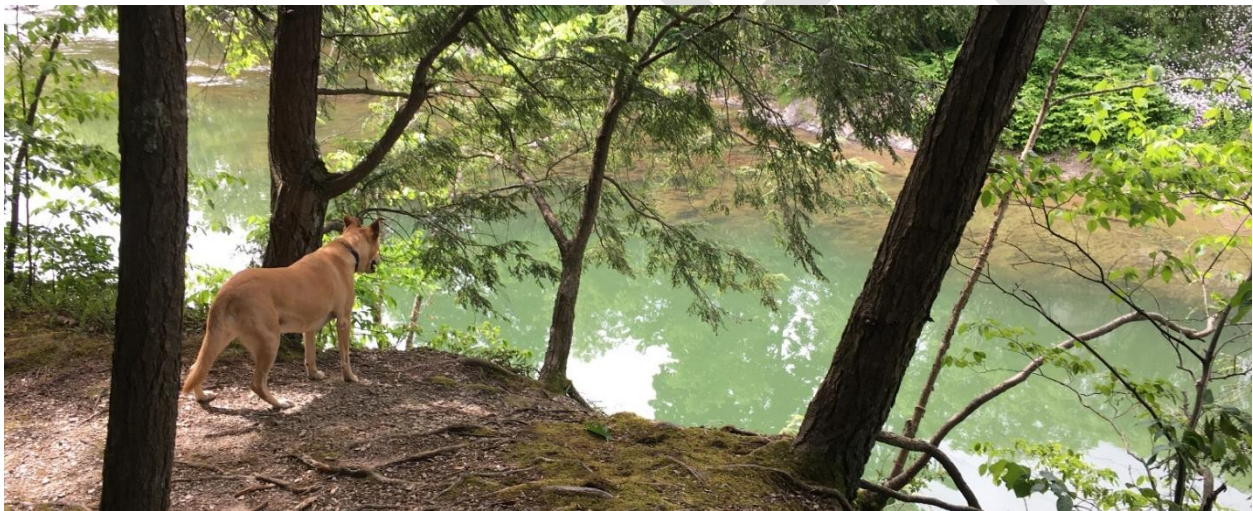
The preserve has a network of trails and several points of access down to the creek. In the eastern portion of the preserve the shore is very steep, high, and exposed down to the bedrock. The landscape at the top of the bank is comprised of hemlock trees and undulating terrain. The distance to the shore along the vertical slope is lengthy in some locations. Washouts are common where vegetative cover is insufficient. A trail is sited extremely close to the top of this bank without any railing. This could be a fall hazard for visitors to the preserve. A switchback trail guides visitors down to the creek near the parking area. The trail is quite steep, and since it is simply a dirt footpath it can become slippery during rain events. Erosion of the trail and surrounding terrain in steep sections is found throughout the preserve.

Figure 4: Steep, unprotected slopes in the eastern section of the preserve.

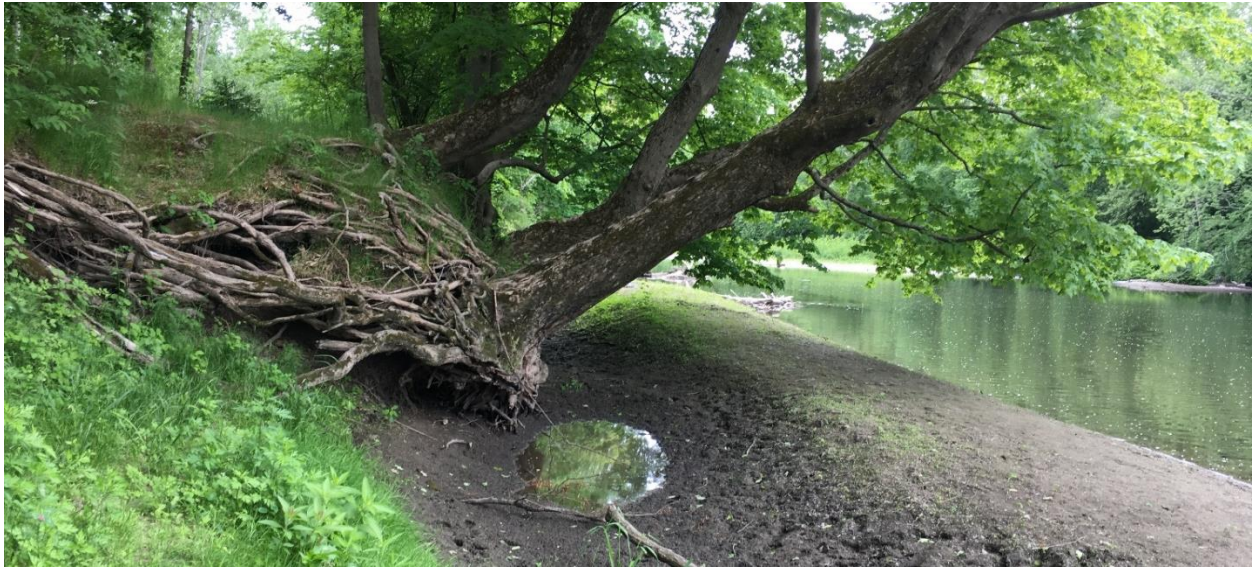
The shore is variable along the length of the preserve. Some stretches are comprised of rocky outcroppings with sand and gravel margins adjacent to the water. These sites are stable – gravel and sediment will shift over time but the shore itself is unlikely to change. Other sites are similar to what is found at the River Street Park on the northern banks of the Kinderhook. The shores tend to be held together with a range of tree species typically found in riparian systems (cottonwood, maple, and sycamore). Grasses, wildflowers, and vines (primarily non-native) are in abundance, but woody understory species are lacking. When flooding occurs, the herbaceous species lay flat, subsumed by the rush of water. The stems and root systems of riparian shrubs are flexible and strong and can withstand fluctuations in water levels and intermittent flooding. A berm was observed along the shore in one location. The berm is unvegetated – it is unclear if it was constructed or if over time sediment has accumulated in this uniform shape.

*Figure 5: Berming and undercutting of the bank.*

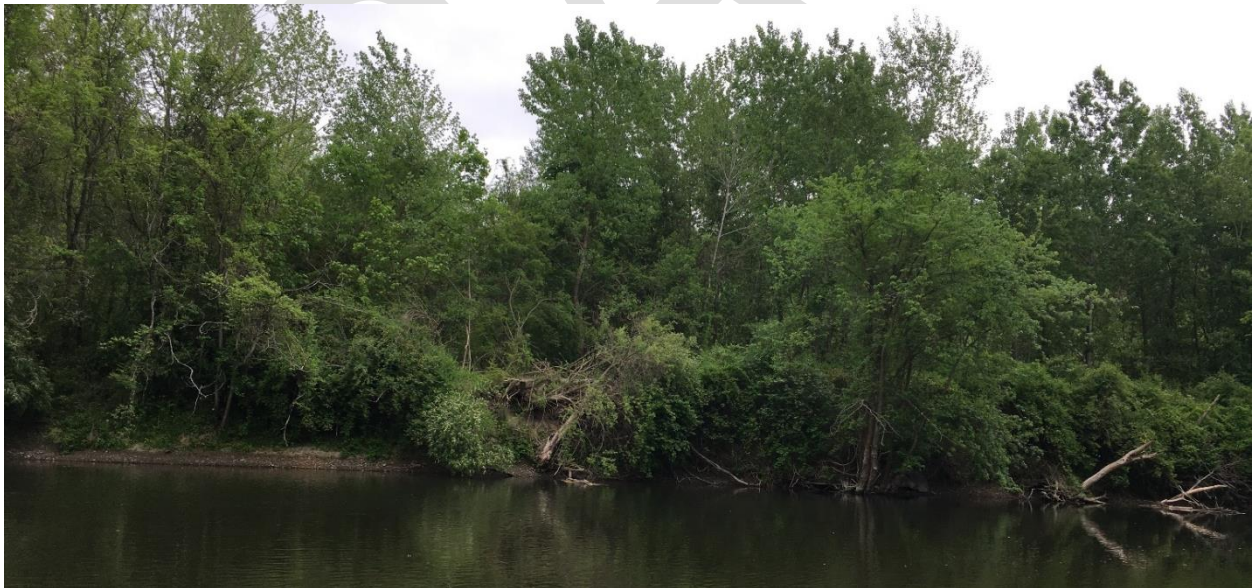
Where the shore lacks a bedrock ledge, severe undercutting and collapse of the shore is pervasive. The steep vertical distance makes this problem even more pronounced; where the shore has been washed away pioneering vegetation has a difficult time establishing. This problem persists downstream beyond preserve property - it is therefore common to find spans of barren slopes with a lipped top of bank slowly receding into the upland forest.

*Figure 6: Steep, collapsing shoreline along on the southern side of the Kinderhook Creek.*

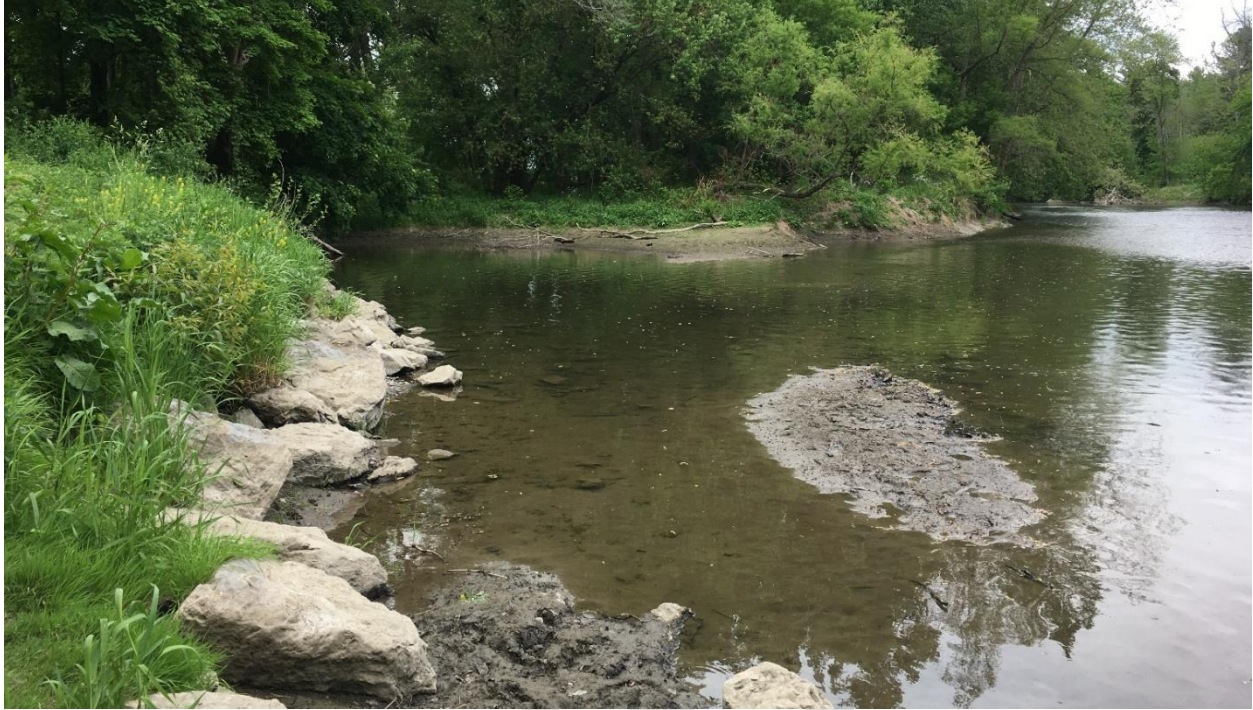
A small inlet of shallow water is found along the banks of the creek, behind which extends a forested riparian buffer. The topography is gradual in slope, with a drainage depression from the inlet north toward an agricultural landscape. The inlet can be accessed via a trail through the forested shoreline adjacent to the creek. Emergent wetland species are found in the inlet and other species may emerge as the season progresses. There is no formal boating launch at the inlet and the trail is a

Figure 9: Riprap with steep edge to the south of the inlet.

Construction of a kayak/canoe launch is recommended to ensure safe access for visitors, stabilizing the adjacent slope and expanding recreational activities along the creek. In addition, the riparian

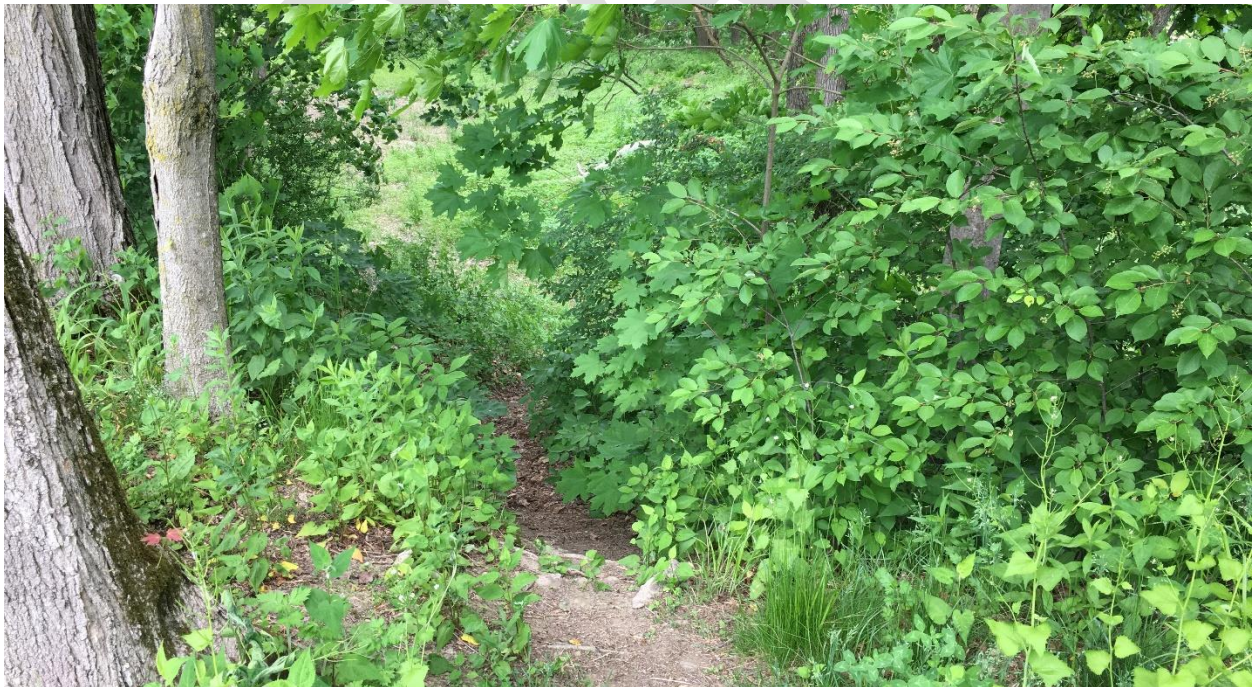
Figure 10: Existing footpath down to the inlet.
